HITLER'S TANKS

GERMAN PANZERS OF WORLD WAR II

EDITED BY
CHRIS McNAB

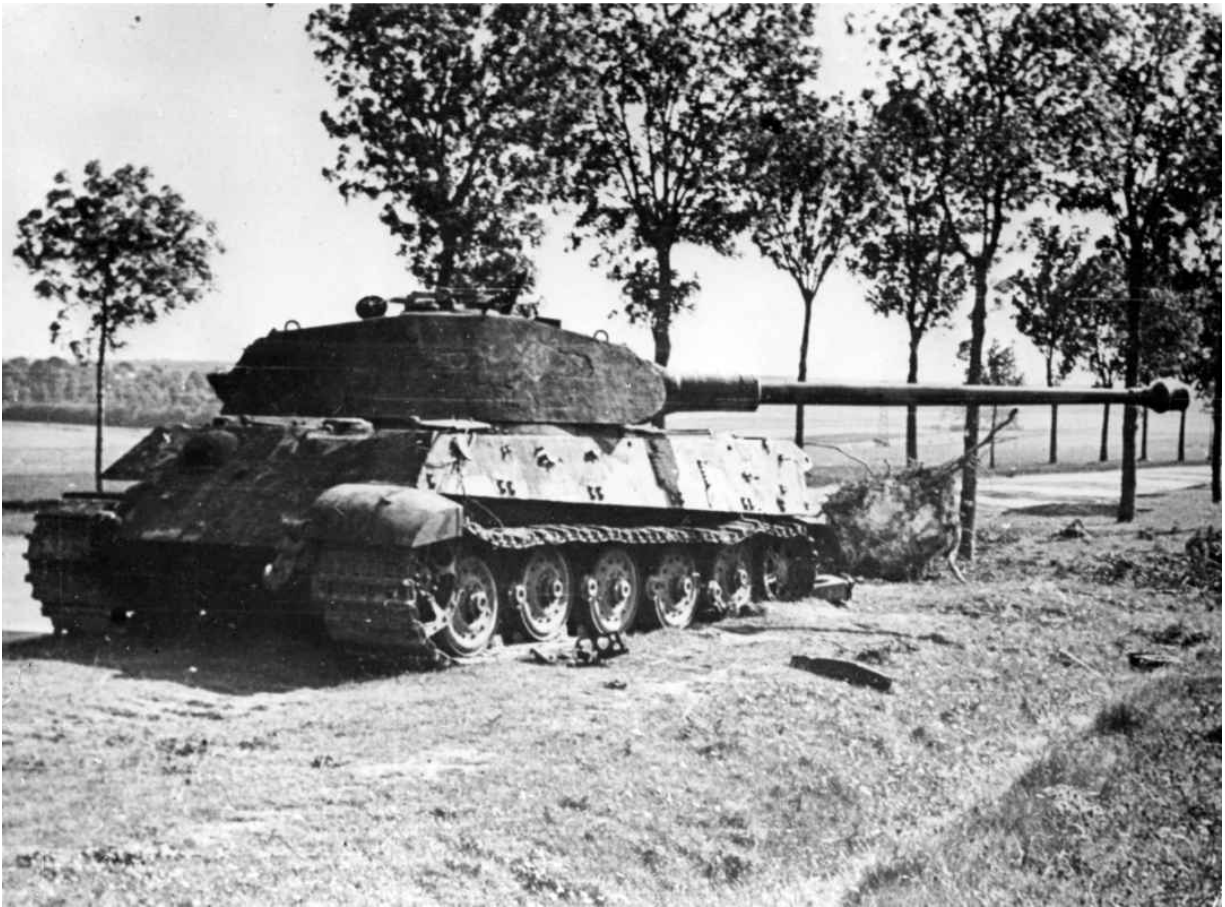
A PzKpfw Tiger Ausf B with the Porsche turret. Porsche's design requirement for a 1,900mm turret ring proved too small for the 8.8cm main armament. (AirSeaLand/Cody)

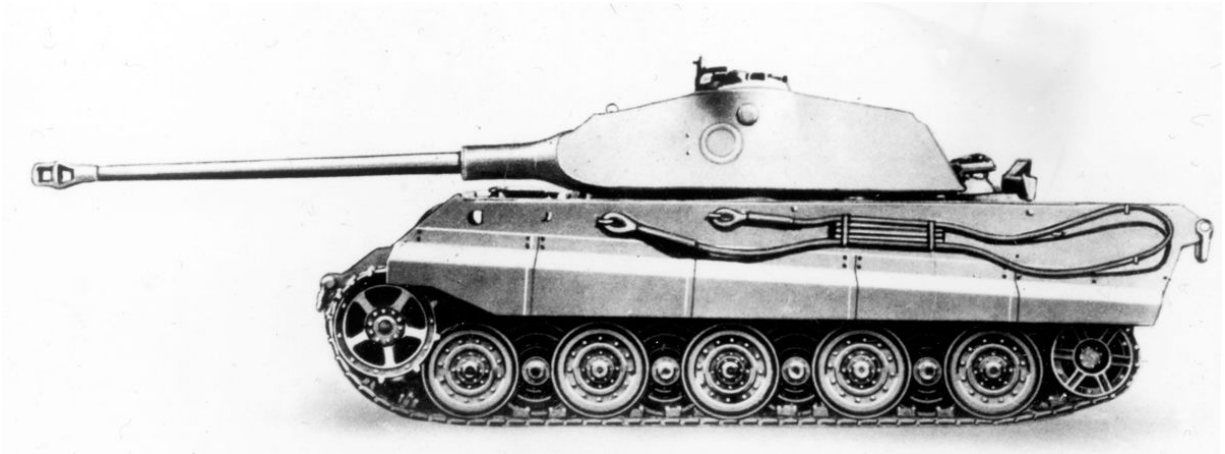
A PzKpfw VI Ausf B Tiger II with a Porsche turret. Porsche's VK 45.02 (P) proposal was based on their previous attempt to secure the Tiger I contract. (AirSeaLand/Cody)

As part of this *Tigerprogram*, Henschel's updated VK 45.03 (H) possessed the long 8.8cm KwK 43 main gun coupled with sloped armour that resembled a bulked-up medium Mark V Panther. To simplify future maintenance and supply, the Tiger II also included transmission, track, engine cooling system and other components that were interchangeable with the proposed Panther replacement. Hitler's calls for thicker armour and improved manoeuvrability meant that work on the prototype was slower than anticipated as the vehicle's side panels had to be strengthened during production to compensate for the added weight.

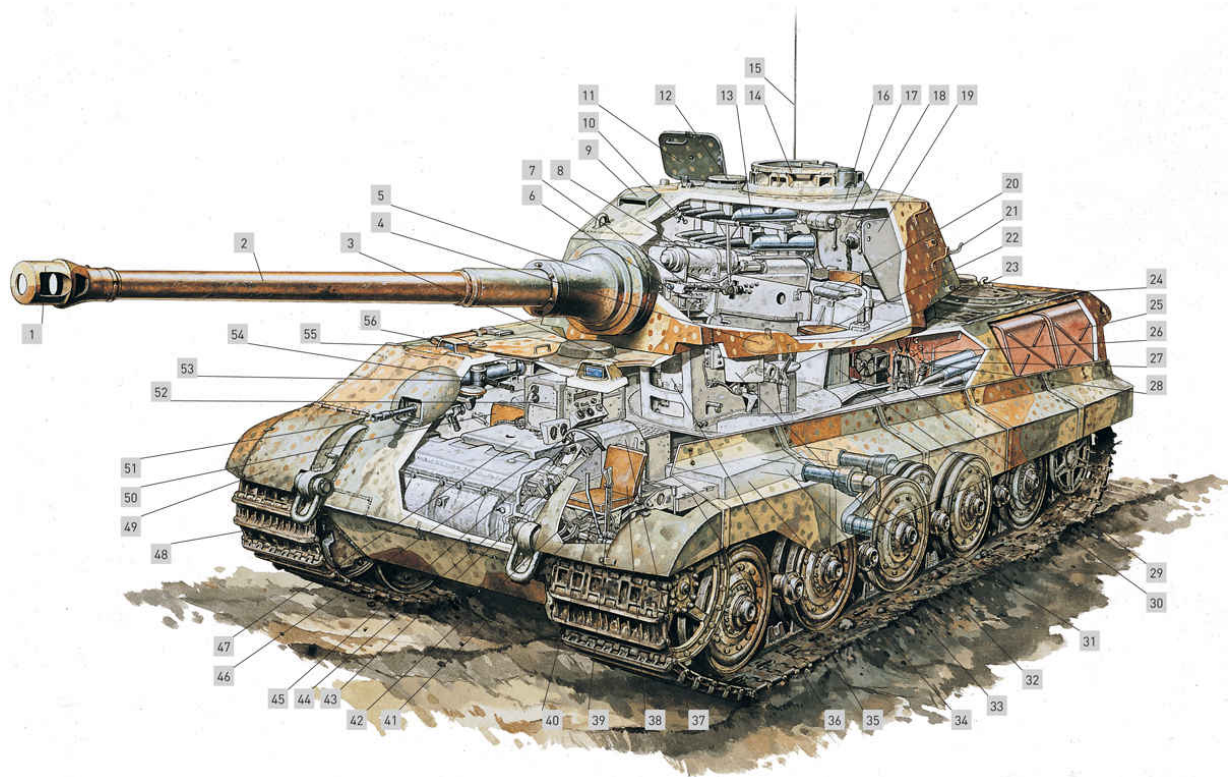
PZKPFW TIGER II AUSF B 'HENSCHEL TURM'

- 1.** Muzzle brake
- 2.** 8.8cm KwK 43 L/71 gun
- 3.** Driver's hatch
- 4.** Loader's auxiliary traverse wheel
- 5.** Gun mantlet
- 6.** Gunner's turret traverse wheel
- 7.** TZF 9b monocular sighting telescope
- 8.** Main gun recuperator and recoil mechanism
- 9.** Loader's periscope
- 10.** *Nahverteidigungswaffe 'S'* mine projector

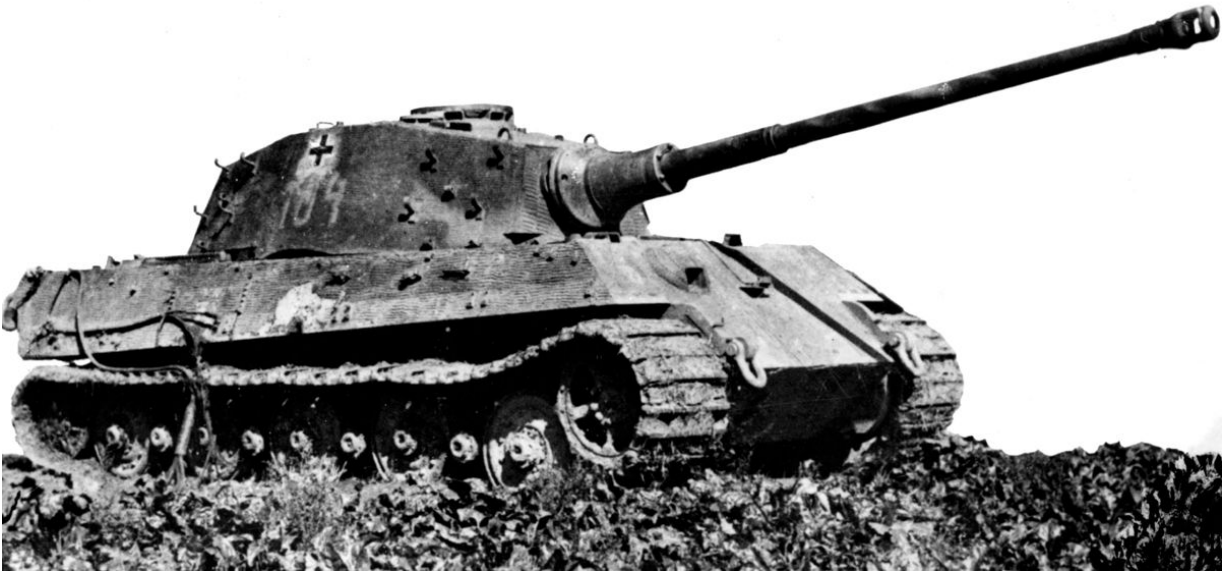
This photograph of a Tiger II nicely illustrates the curved upper profile of the turret, one of the key design elements that distinguished the vehicle from the Tiger I. (AirSeaLand/Cody)

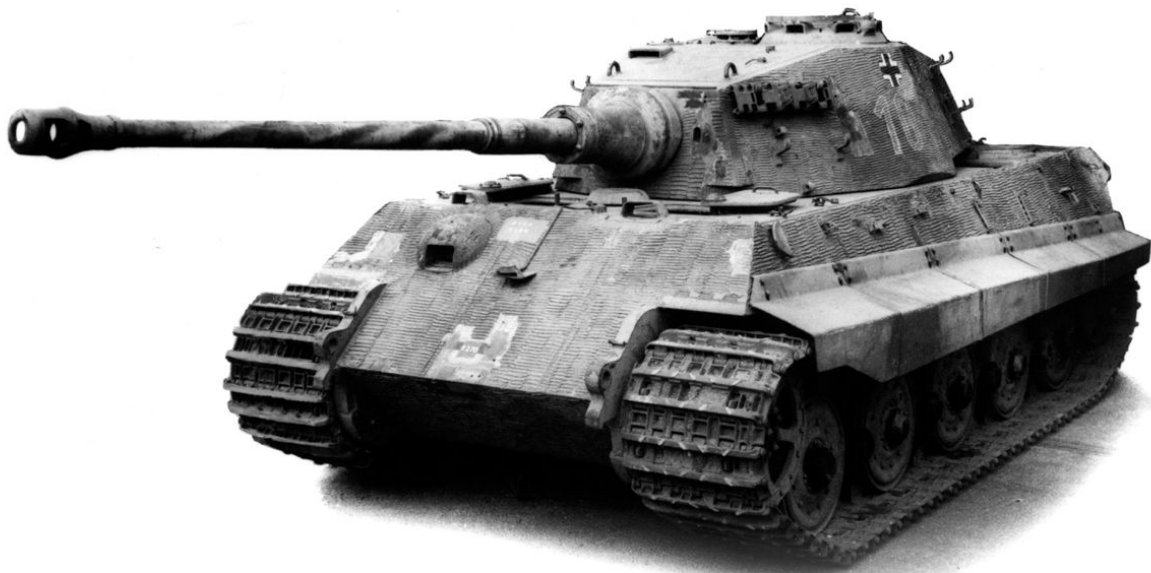
In this view of the Tiger II the width of the tracks is evident – they measured 800mm wide, giving even such a heavy tank a generally practical ground pressure. (AirSeaLand/Cody)

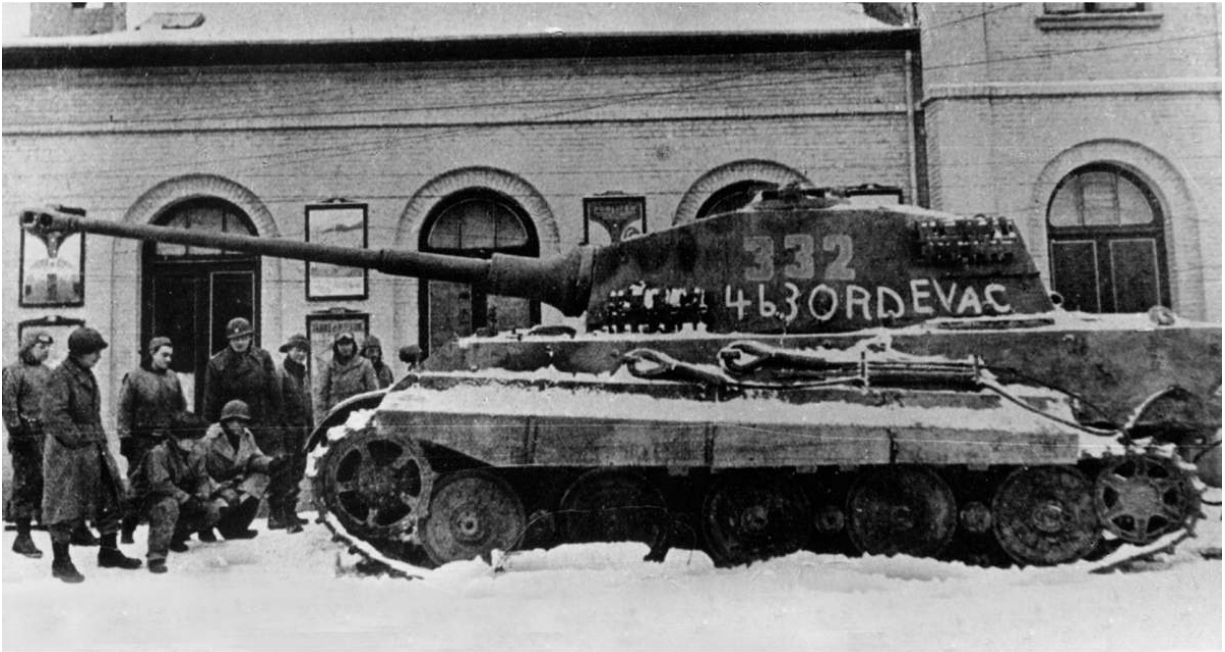
A Tiger II Ausf B captured by US troops in Belgium, 1944–45. In May 1944, a new type of track was introduced that minimized uneven wear and helped prevent it from climbing over the drive sprocket when in motion. (AirSeaLand/Cody)

The original *Geländekette* (operational track) Gg 24/800/300 design for the Tiger II had double track links, consisting of the main link, a connecting link with three end connectors and two track pins. This design allowed the same track to be mounted on both the left and right side, without causing the vehicle to pull to one side. Each double link weighed 62.7kg and was driven by a sprocket with 18 teeth. This double link design was very loose, with little resistance to bending, and therefore little power was wasted in driving the tracks. However, this original track design was prone to climbing on to the sprocket and thereby being jammed or thrown. Due to the variations in the track pitch between links, the sprocket teeth wore unevenly, which was an indication of destructive stresses to the internal drive train components.

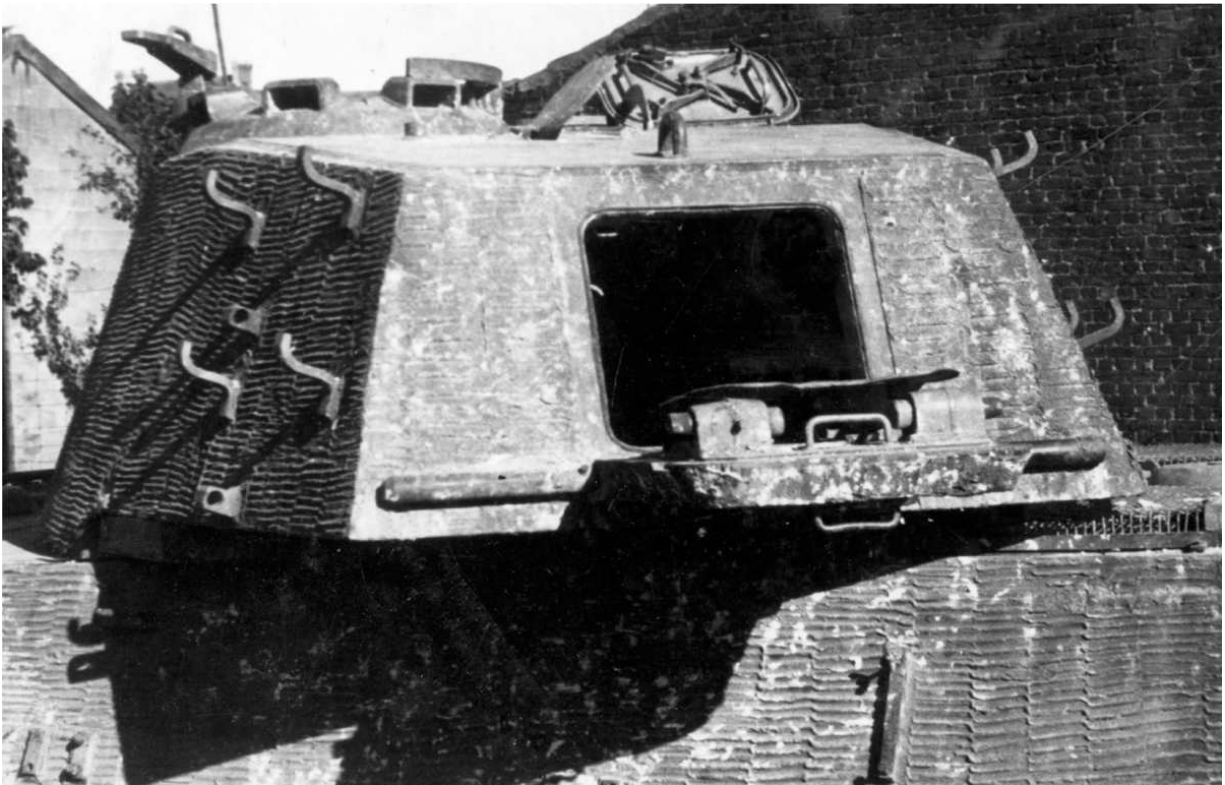
The rear turret of the Tiger II, liberally covered with Zimmerit anti-magnetic mine paste. The paste was applied to the vehicle in the factory and hardened with direct heat.

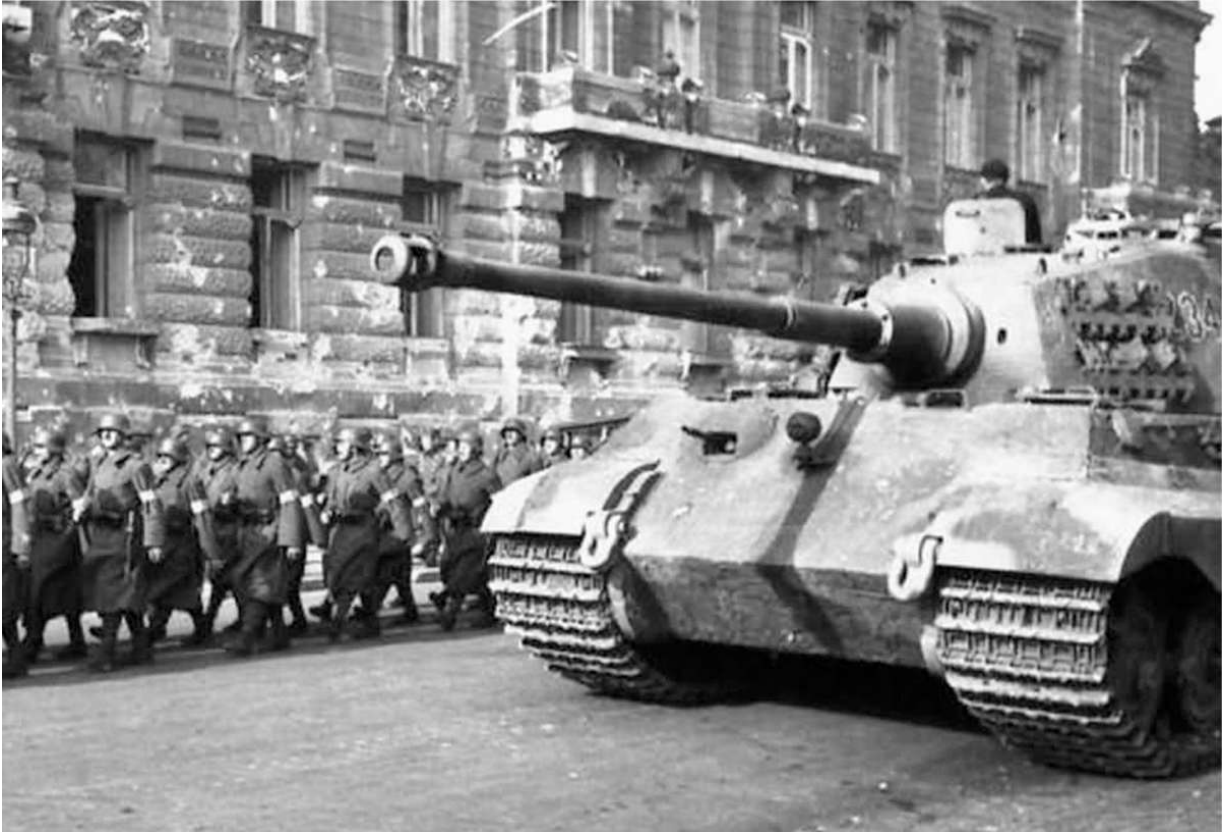
A Tiger II on the streets of Budapest, Hungary, in 1944. It has a production turret (as evidenced by the two-piece barrel) and a Bosch headlight on the glacis. (AirSeaLand/Cody)

The original production version of the 8.8cm KwK 43 (L/71) consisted of a one-piece monobloc gun tube. Starting in May 1944, this was gradually replaced by a two-piece sectional monobloc gun tube that was easier to produce in quantity with no degradation in the performance. A lighter, smaller muzzle brake was fitted to the sectional monobloc guns.

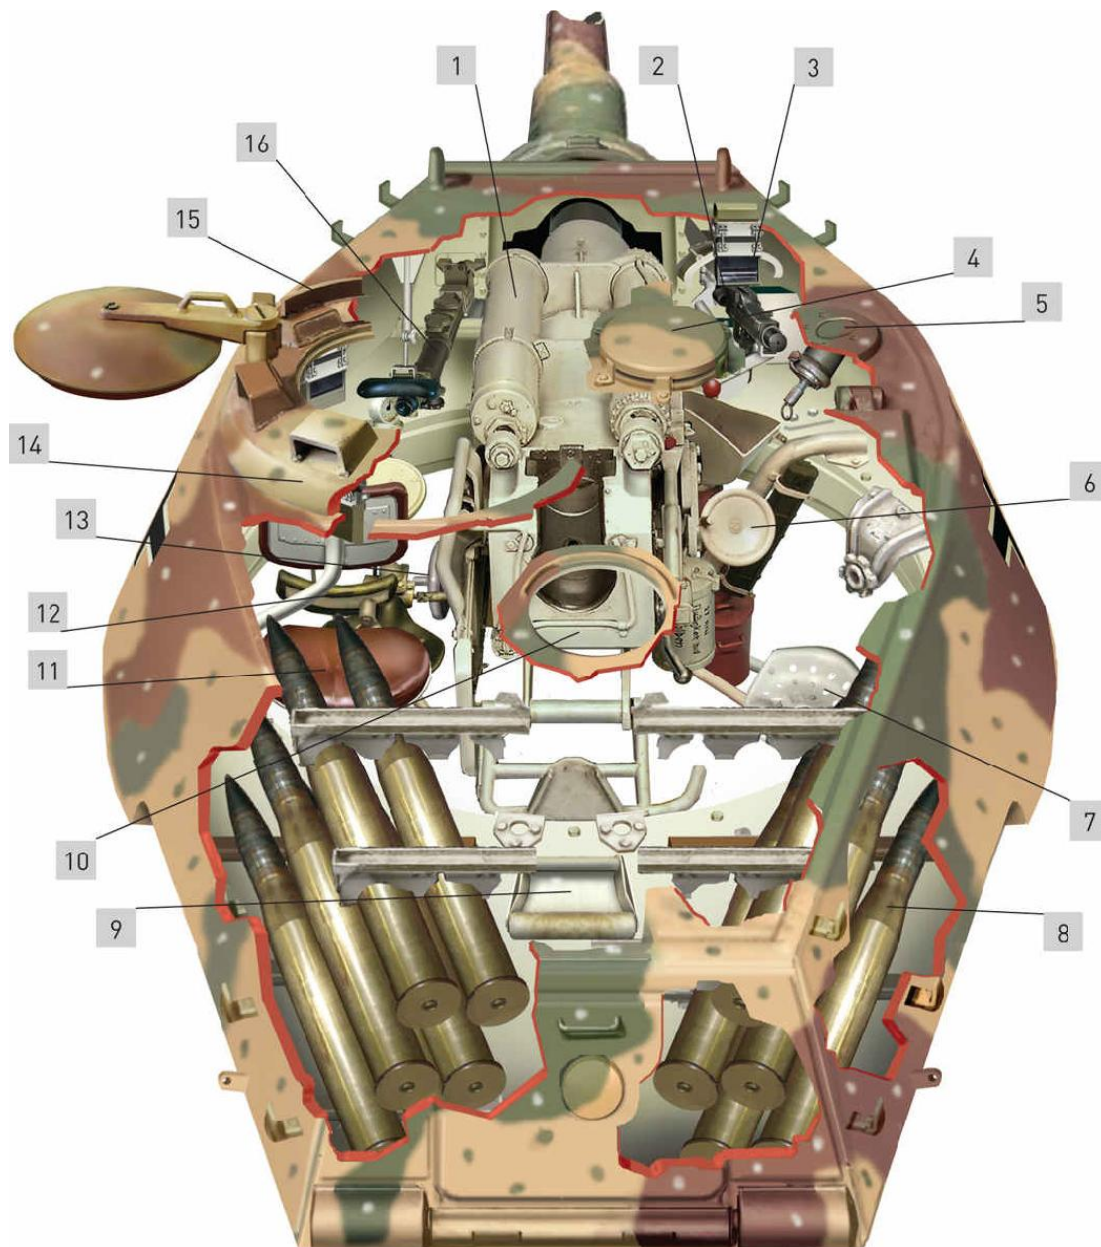
KING TIGER TURRET

- 1.** Recoil cylinder
- 2.** Coaxial 7.92mm MG 34
- 3.** Loader's forward vision port
- 4.** Turret ventilator

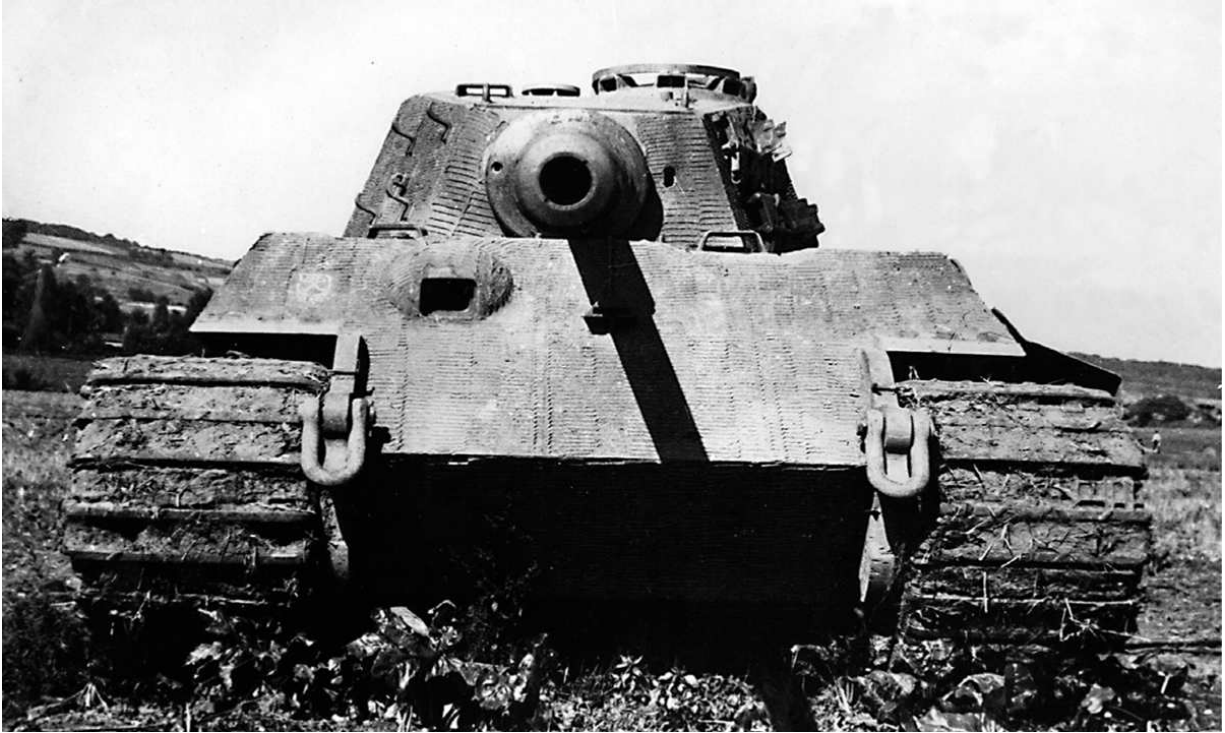
This view of a Tiger II shows the squat front profile of the tank. Dust shields normally seen over the tracks have either been removed or were not fitted. (AirSeaLand/Cody)

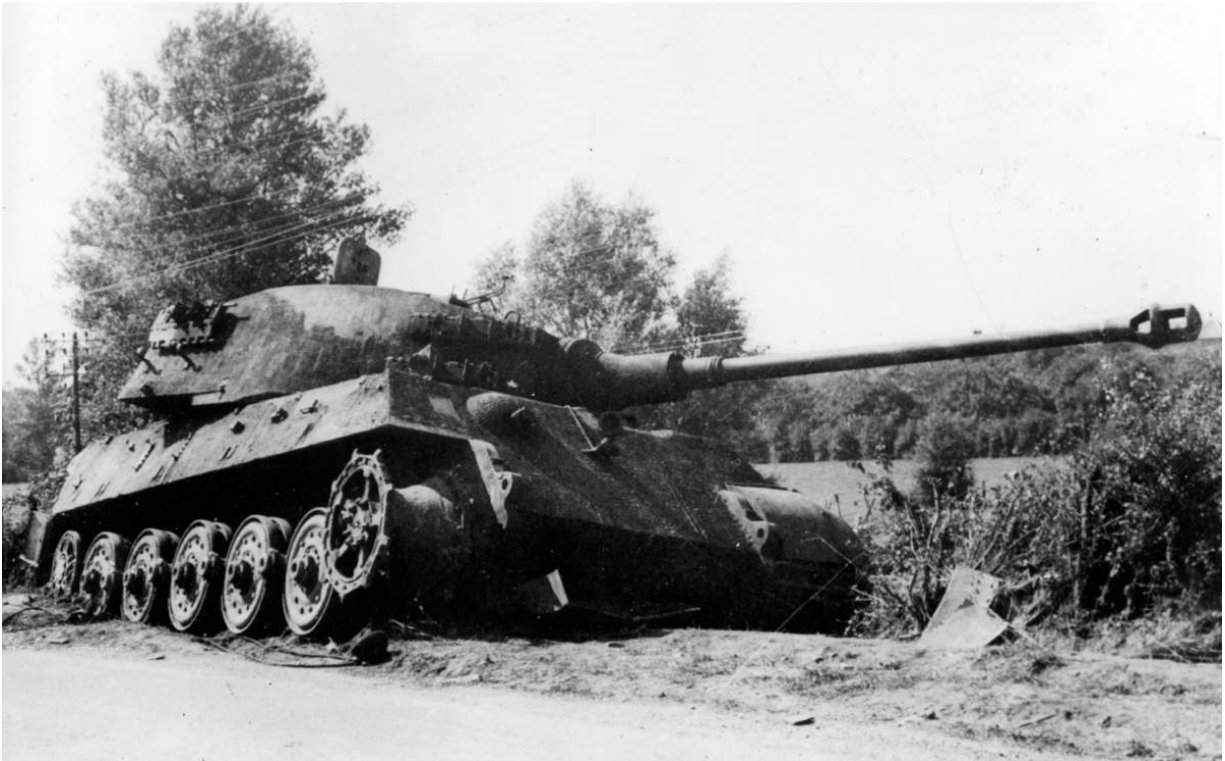
A knocked-out Tiger II, its right-hand track completely gone. The Tiger II incorporated a twin steel-rimmed, rubber-cushioned type of road wheel, which improved maintenance and cold-weather operation as ice and snow were less likely to impede rotation.

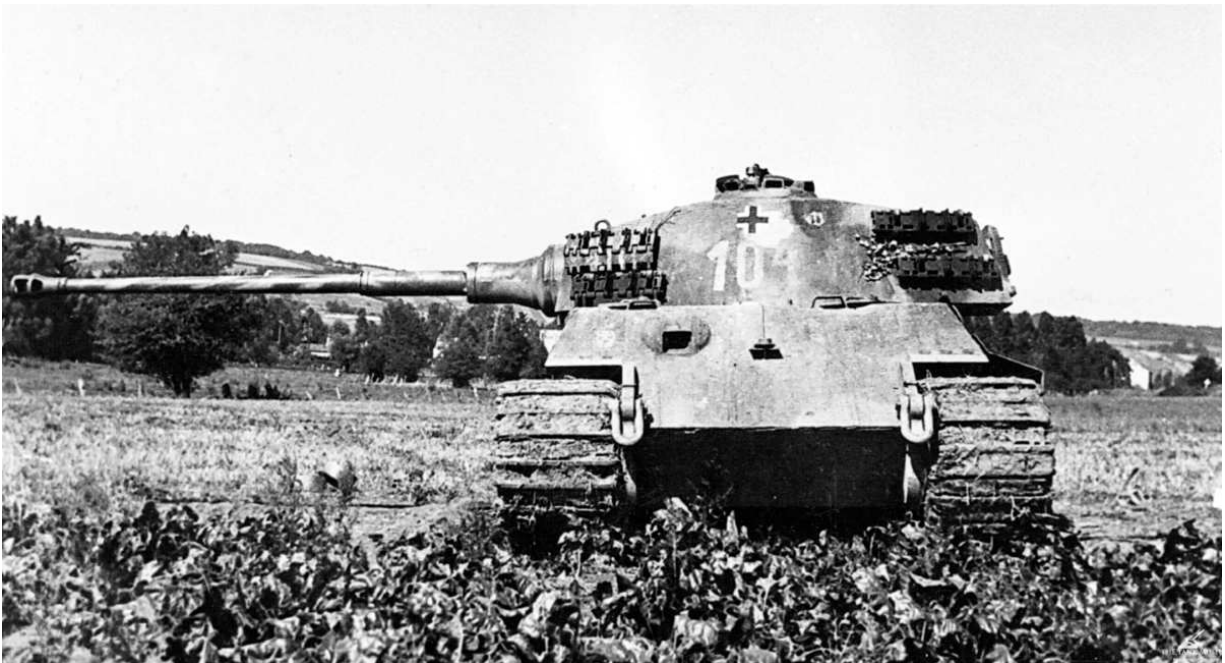
For the Tiger II, Krupp and Rheinmetall-Borsig produced two prototypes of the new 8.8cm KwK 43 L/71 gun, with the former being an entirely new design and the latter simply a reworked Flak 41 L/74. As Krupp's version was shorter, possessed a muzzle brake and used shorter, more easily stored projectiles, it was deemed superior and accepted for production.
(AirSeaLand/Cody)

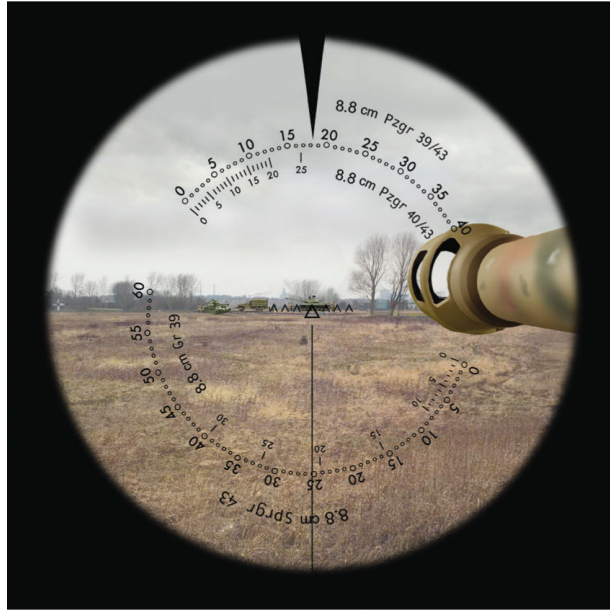
TIGER II GUN SIGHT

Here we see the view through a Tiger II's TZF 9d gun sight targeting a Red Army IS-2 as it and another are resupplied by a Lend-Lease supply truck. Believing themselves to be safely out of enemy range, the two halted IS-2s take on supplies and fuel before moving up for an attack. Soviet support personnel go about their business next to an American IHC M-5-6×4-318 supply truck. When the Soviets went over to the strategic offensive in 1943, foreign-provided Lend-Lease equipment and vehicles such as this one greatly assisted with logistics. The Tiger II's firing sequence proceeds similarly to that of the IS-2. With a projectile ready in the breech, and if the target is beyond some 500m, the gunner estimates the target's actual size and divides it by the number of mils it encompasses in the scope. The loader adjusts the tick marks on the TZF 9d monocular gun sight in accordance with both the selected ammunition and the range, the latter being agreed upon by the driver, gunner and commander. Once it is rotated so that the large black triangle at the scope's top points to the estimated range, the upper tip of the large central triangle atop the vertical line is located between the targeted IS-2's turret and hull.

A Tiger II gunner uses his TZF 9d sight to target a Soviet IS-2 heavy tank as it is resupplied by a US Lend/Lease supply truck at 1,800m.

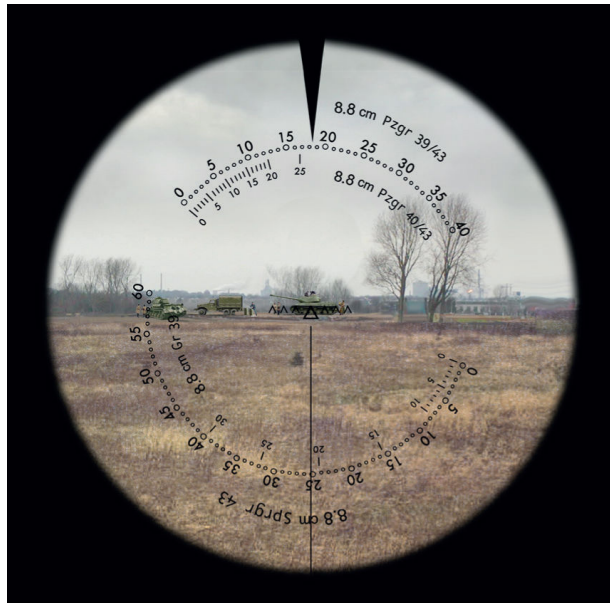
Fine-tuning his aim from 2.5× to 5× magnification, the gunner prepares to fire a Pzgr Patr 39/43 APCBC/HE-T round into the unsuspecting enemy vehicle's thinner side armour.

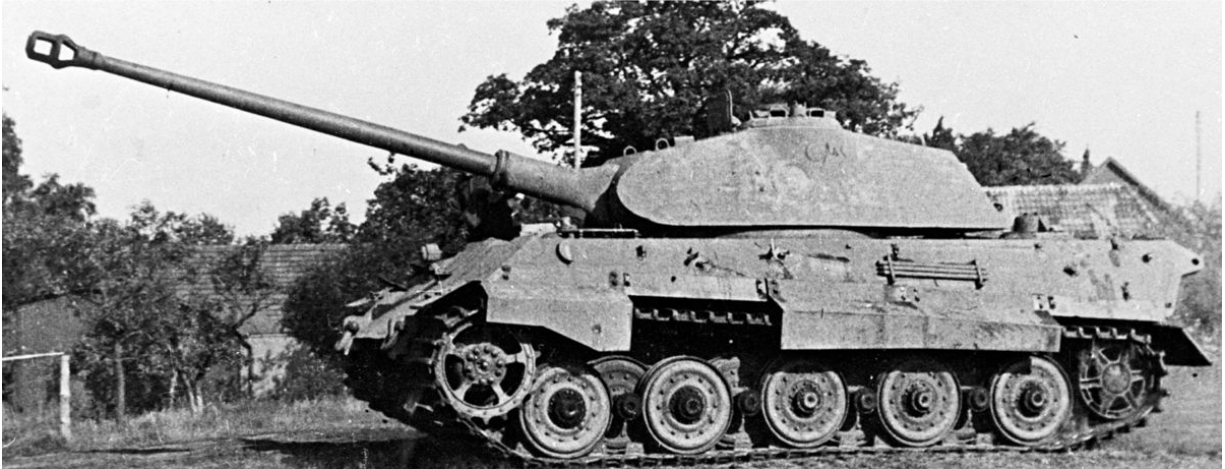
This Tiger II is missing sections of the armoured skirt that ran along the side of the vehicle, protecting the upper portion of the tracks. (AirSeaLand/Cody)

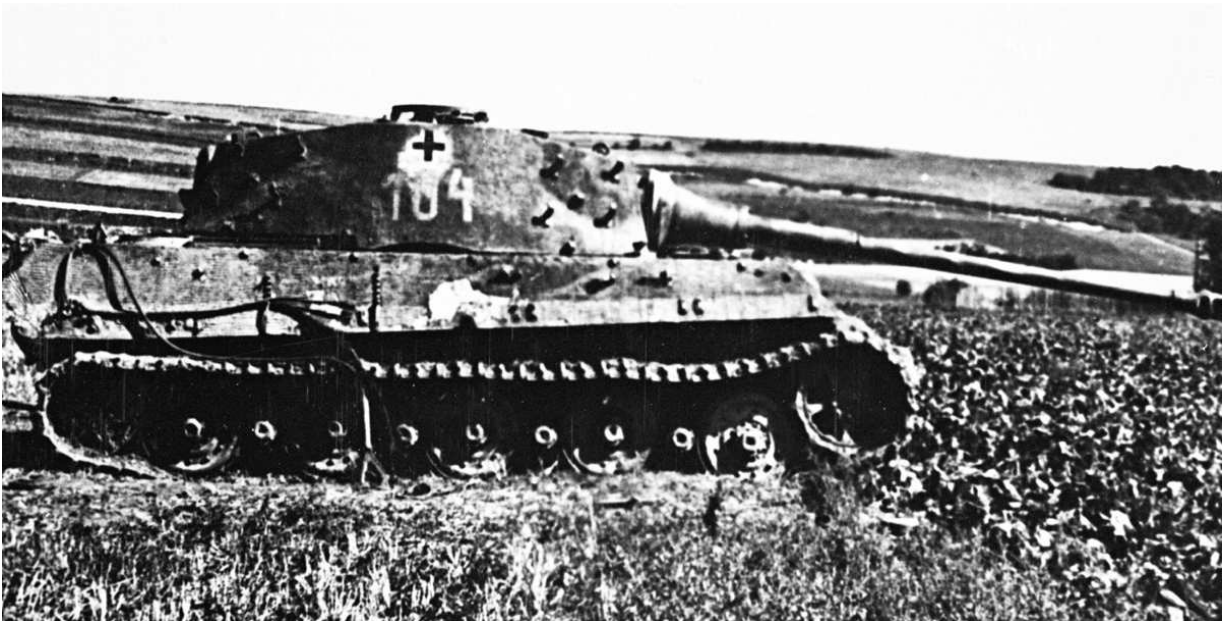
A knocked-out Tiger II in France in 1944, there being indications of shell damage to the hull and the lower lip of the turret. (AirSeaLand/Cody)

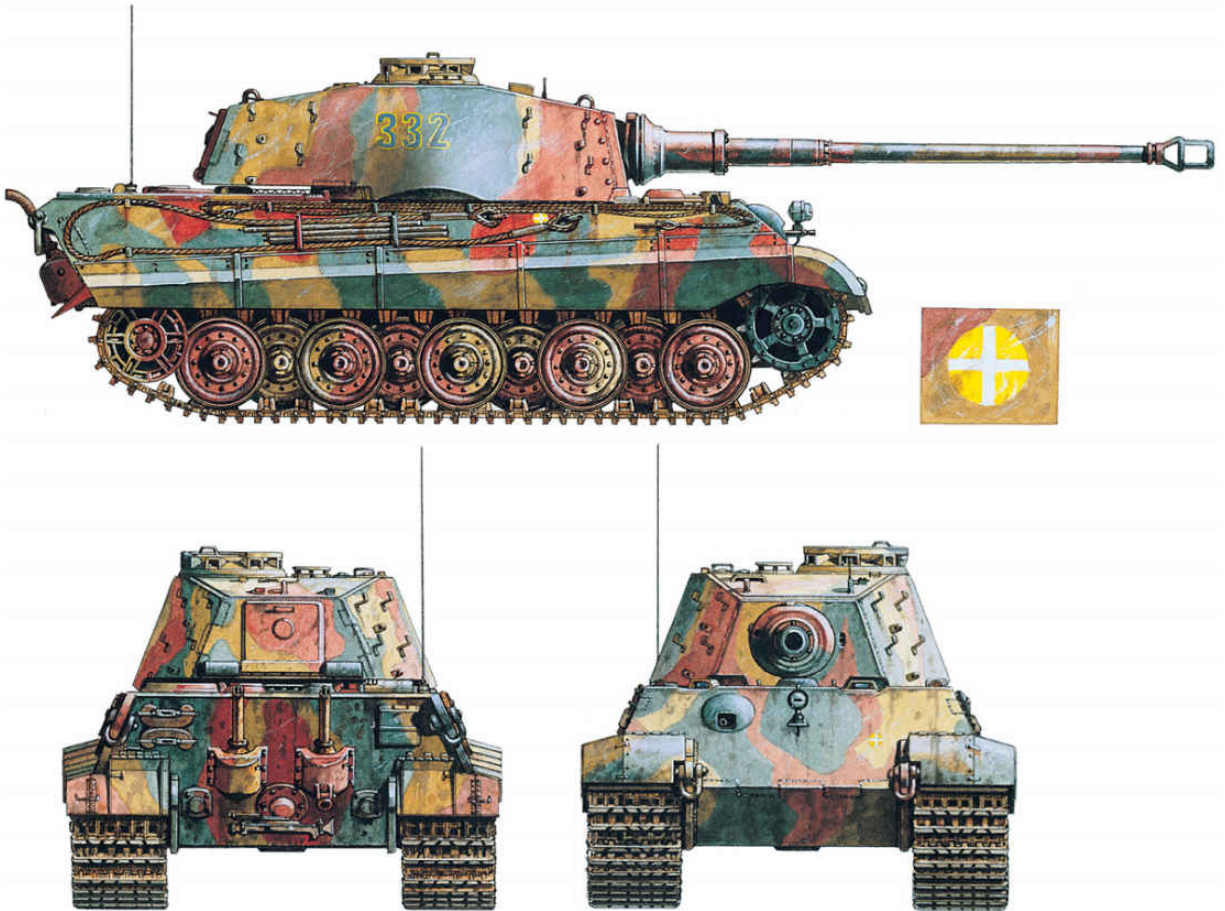
Tiger II, schwere SS Panzer-Abteilung 501; Ardennes, December 1944. The Tiger II now on display at the Armour Proving Ground, Aberdeen, Maryland, was captured from the SS 501st. However, it was originally issued to the 509th and then handed over to the SS 501st to complete their establishment of 45 Tiger IIs for the Ardennes offensive.

intended for the 509th were confiscated at the last minute and turned over to the SS 501st. The Tiger II (Fgst Nr 280243, completed at Henschel on 8 September 1944) now in the collection of the Aberdeen Ordnance Museum in Maryland was one of these 11. This explains the puzzle of why the tactical markings of the 509th were on a Tiger II captured in Belgium from the SS 501st.

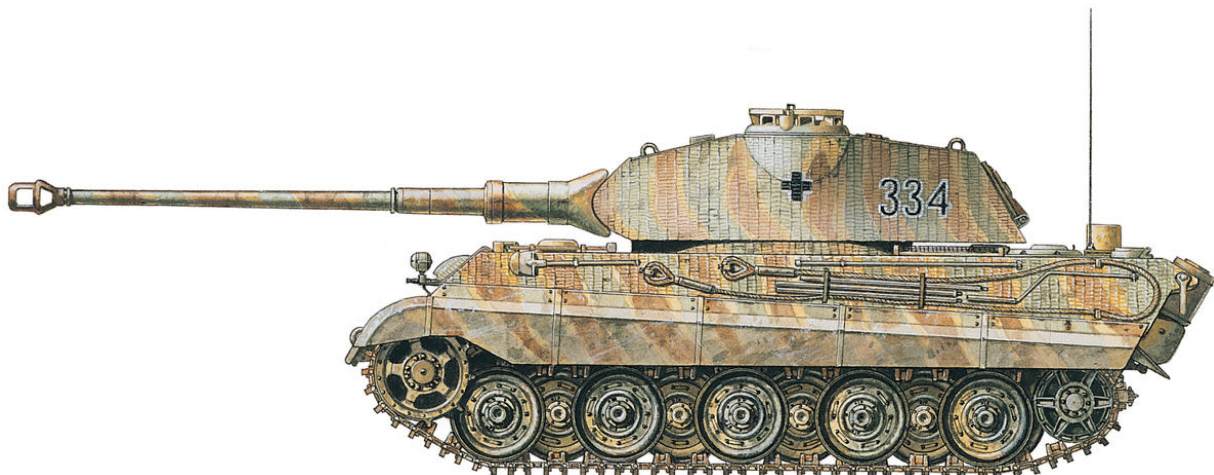
1) Tiger II 'Porsche Turm', Panzer Ersatz und Ausbildungs Abteilung 500. The Panzer Ersatz und Ausbildungs Abteilung 500 (Replacement and Training Battalion) 500 was equipped with some of the earliest production Tiger IIs. At this period all Tiger IIs were coated in Zimmerit.

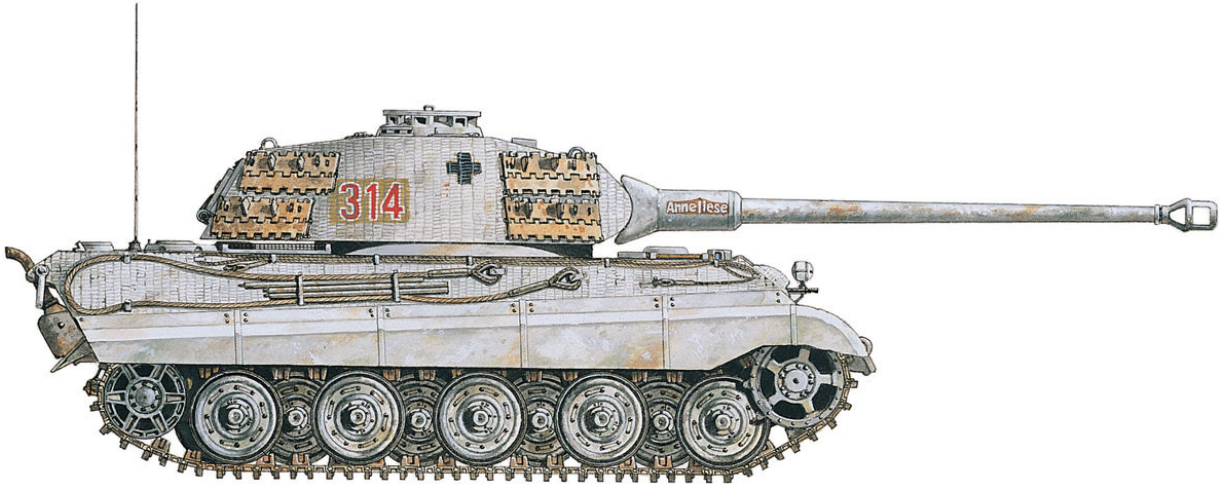
2) Tiger II 'Porsche Turm', schwere Panzer-Abteilung 503; Russia, Winter 1944–45. Tiger IIs of the 503rd fought in France against the Allied forces in the summer of 1944. Their Tigers were painted similar to that in 1.

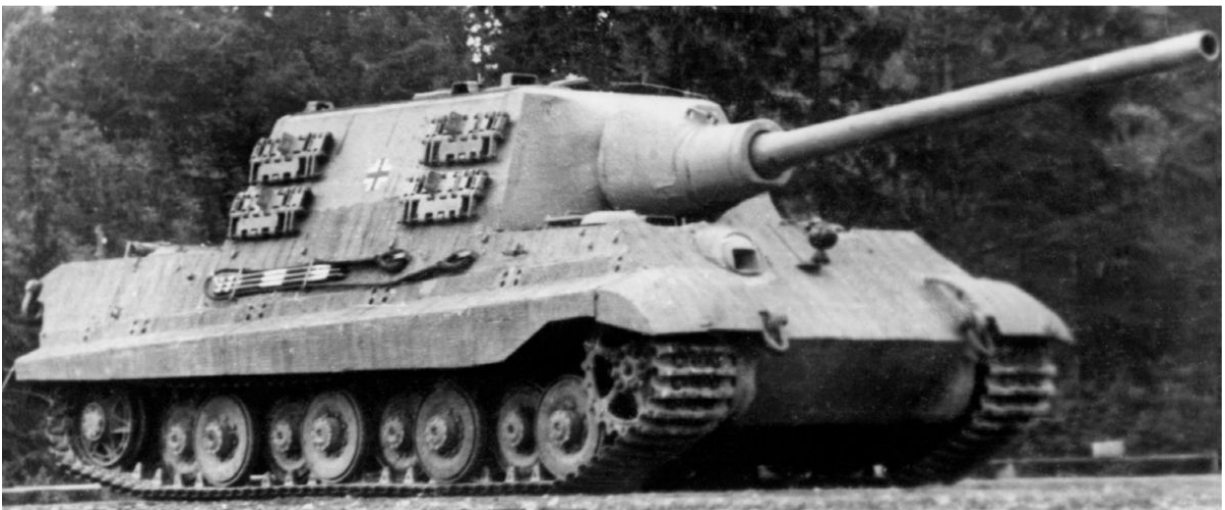
The Panzerjäger Tiger Ausf B, also known as the Jagdtiger ('Hunting Tiger'), was a truly monstrous vehicle, armed with a 12.8cm PaK 44 L/55. It was also an expensive and unnecessary distraction at a late stage of the war. (AirSeaLand/Cody)

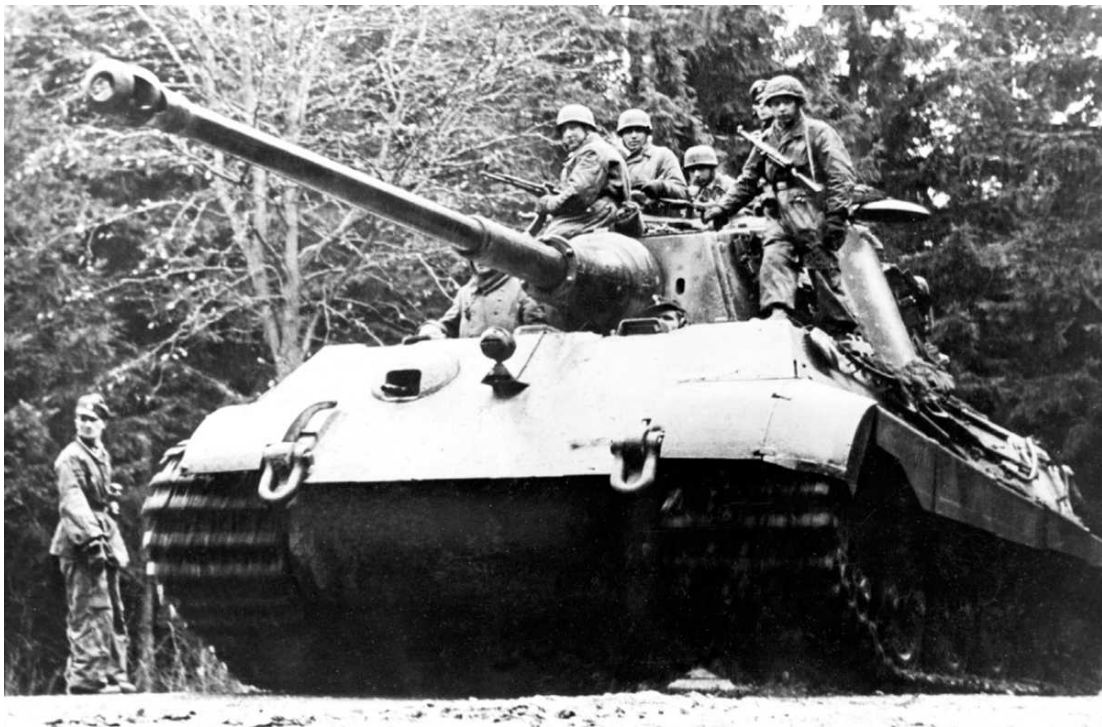
German paratroopers hitch a ride on a Tiger II during the Ardennes offensive in 1944. The two heavy towing rings are visible on the lower glacis plate. (AirSeaLand/Cody)

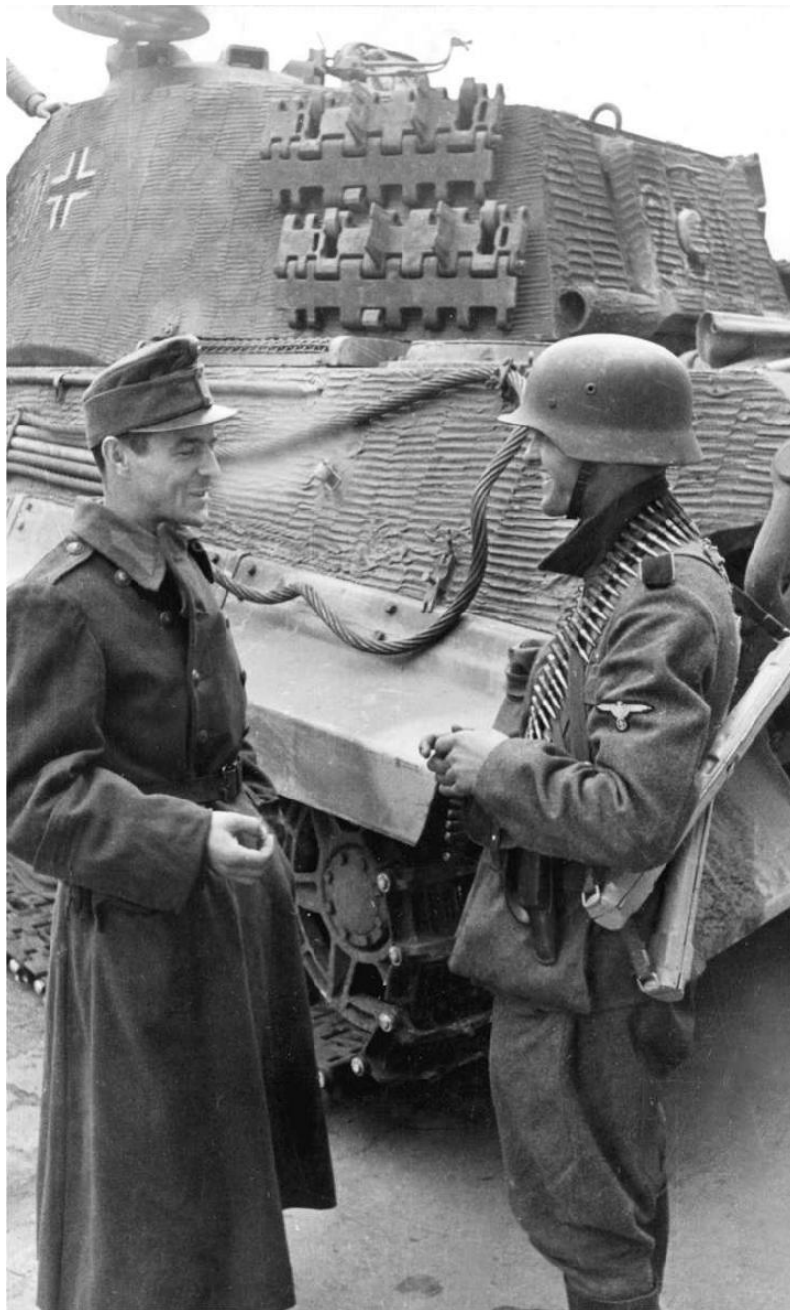
A Romanian soldier talks with a Waffen-SS machine gunner in front of a Tiger II. The deep 'ribs' of the Zimmerit paste are evident here; it worked by reducing the adhesion of a flat-bottom magnetic mine, which could not sit flush against the metalwork. (AirSeaLand/Cody)

By an order dated 9 September 1944, the Zimmerit anti-magnetic coating was no longer to be applied at the factory to new production tanks. This was followed by an order dated 7 October 1944 directed at the troops not to apply Zimmerit to Panzers they received without this coating. These orders were based on rumours that the Zimmerit caught fire from shell hits, which could cause the loss of the tank even if the shells did not penetrate. Tests conducted in November, firing AP, HEAT and white phosphorus shells at two captured T-34s coated with Zimmerit, did not in any case result in setting a tank on fire. However, the orders to stop applying Zimmerit were never rescinded and all Tiger IIs delivered after mid-September 1944 did not receive a coating of Zimmerit.

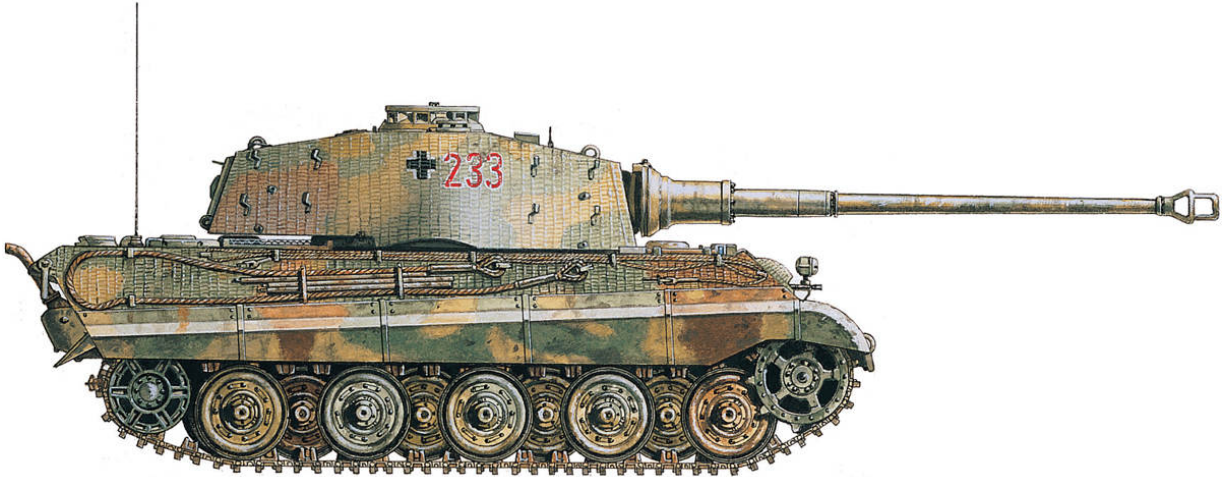
1) Tiger II, schwere Panzer-Abteilung 503; Budapest, October 1944. After returning from France on 9 September 1944, the 503rd was re-equipped with 43 new Tiger IIs with the series (Henschel) turret.

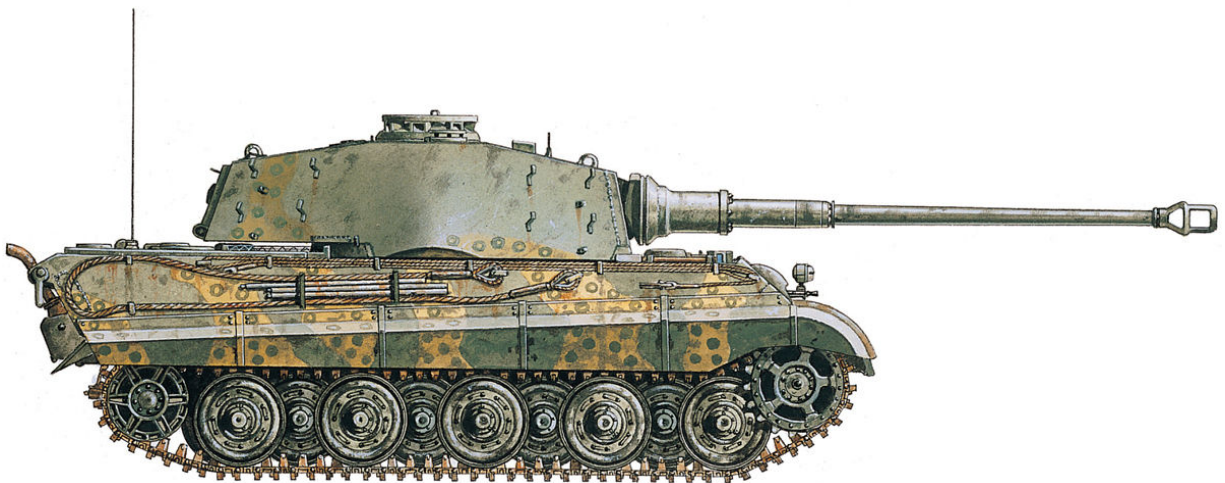
2) Tiger II, schwere Panzer-Abteilung 511; May 1945. The 3. Kompanie schwere Panzer-Abteilung 511 picked up some of the last Tiger IIs from the Henschel factory on 31 March 1945. No markings or call sign had been applied to this Tiger, destroyed in May 1945.

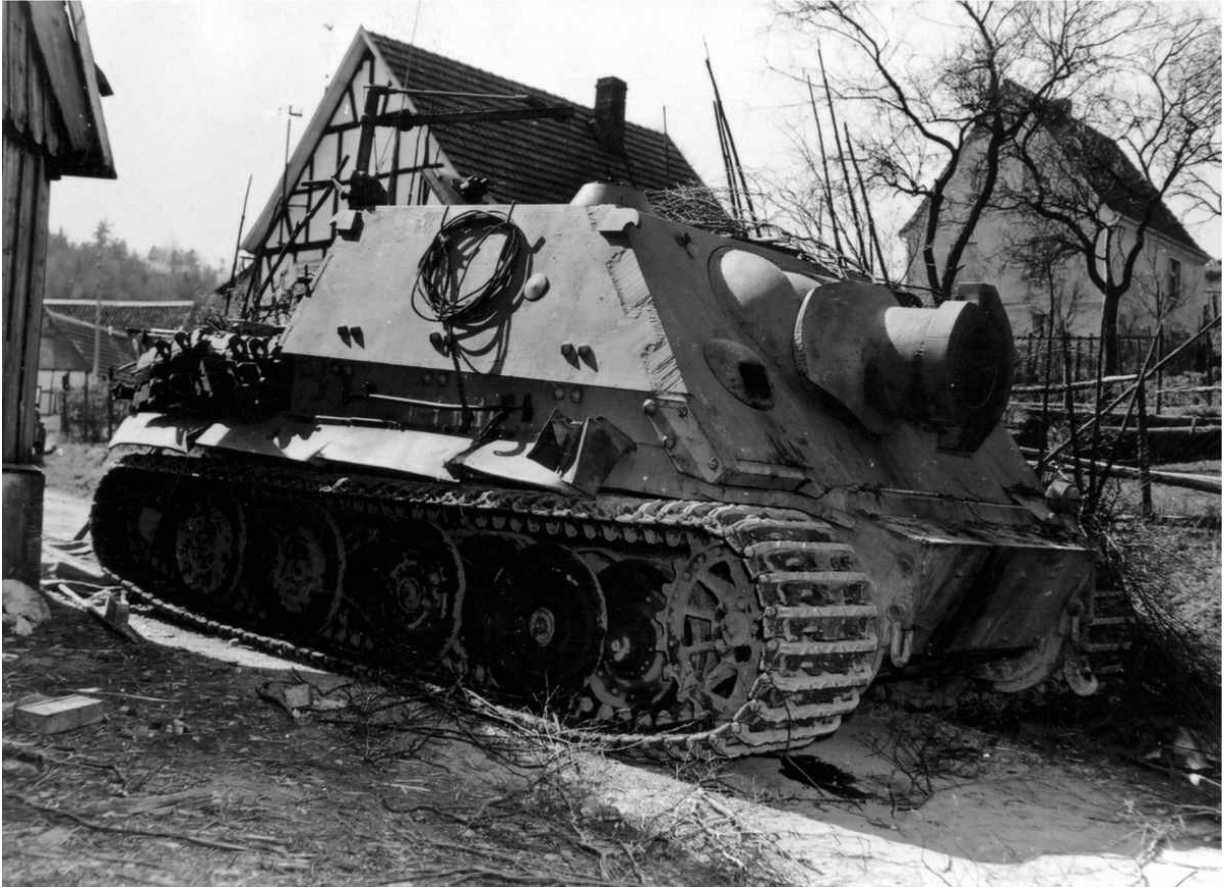
With its monstrous 38cm rocket launcher, the Sturmmörserwagen 606/4 mit 38cm RW 61 (also known as the Sturmtiger) was a heavily urban assault vehicle. Only 14 of the massive projectiles could be stored on board. (AirSeaLand/Cody)
